# Ballistic Testing of Pressurized Hydrogen Storage Cylinders

**Abstract:** *Hydrogen fuel cells have potential as future power sources for military vehicles and power generation systems. Hydrogen storage as a compressed gas presents several safety concerns in military applications. In order to optimize future design and integration work, these risks need to be investigated and understood. This work investigates the behavior of a pressurized hydrogen storage cylinder when penetrated by a ballistic threat, perhaps the greatest safety concern in a military application.*

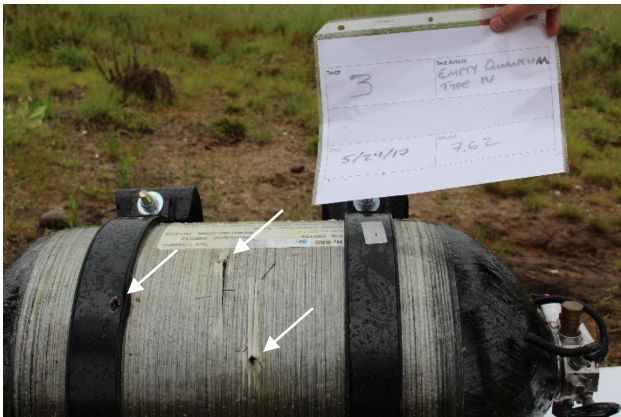
**Figure 1:** Control cylinder after three initial test shots. The arrows indicate where the rounds hit the cylinder.

After several practice shots to sight in the launcher, an empty Quantum tank was used as a control for the test. Two (2) 7.62 ball rounds and one 7.62 armor piercing (AP) round were fired at the cylinder in order to determine if the round could penetrate a tank. The results of these shots were inconclusive. The rounds all clearly struck the cylinder, yet an entry was not clear. Several attempts to probe the entry holes could not determine if the round had completely penetrated the wall of the cylinder. It was thought that the composite liner inside the cylinder had swollen around the entry hole, prohibiting a probe to go through the wall. Though penetration was unable to be determined, the test was continued as several cylinders were equipped with electronic pressure releases that could not be safely depressurized in the field. 7.62 AP rounds were chosen as the default round to increase the probability of penetration. After the test concluded, the control cylinder was cut open to determine if the rounds had penetrated since the entry holes could not be probed in the field. Upon opening the cylinder, a single round was found inside, the armor piercing

round. The entry hole had not swollen, the carbon fiber wrapping of the tank layered back on top of itself making it difficult to probe through. The inside of the cylinder was inspected and no other entry holes were found where the two other rounds had hit the outside of the cylinder. The liner did become slightly delaminated from the wrapping due to the impact even though the cylinder was not pressurized.

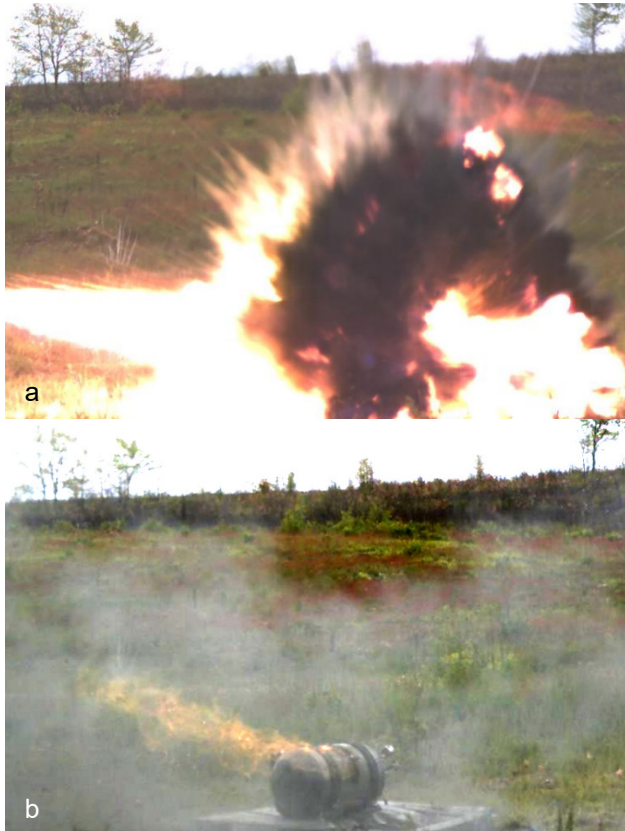
**Figure 3:** RPG impact: (a) the initial detonation of the RPG with initial jet, (b) flame tail sustained briefly after RPG penetration.

The static RPG was fired at a Type IV cylinder. The RPG detonation caused a large jet of liquid metal to be shot through the cylinder. This jet can be seen in Figure 3a. After the RPG was fired, a large cloud of debris and flame enveloped the test site. After the debris began to clear, the burning hydrogen could be observed. A tail of flame was observed coming from the exit hole formed by the RPG. After the hydrogen had completely evacuated the cylinder,
